Gold Quarry Slide – Investigation Project Status Report 16Jun05

Gold Quarry Slide: Geotechnical Investigation, Slide Mechanics Report, and Long-Term Stability Plan

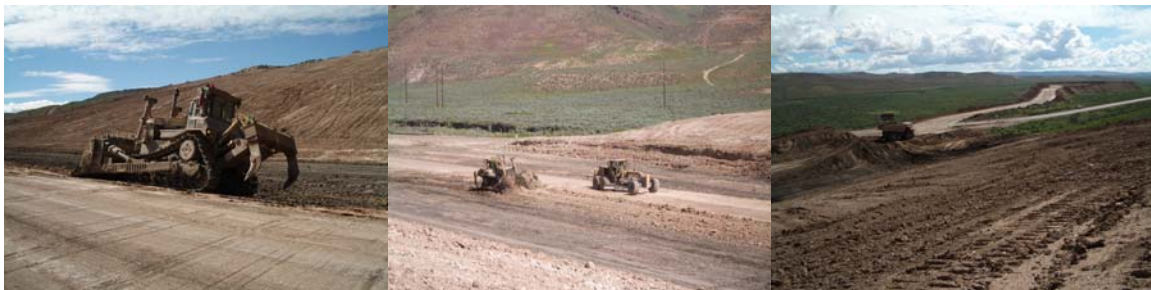
- ⊕ Unweighting: *All currently planned unweighting work has been completed.*
- ⊕ Road Excavation: *Pavement exposure has been completed. Figure 1 shows this activity in progress. Slide material has been removed from the full width of the right-of-way.*

Figure 1. Road (SR766) clearing activities.

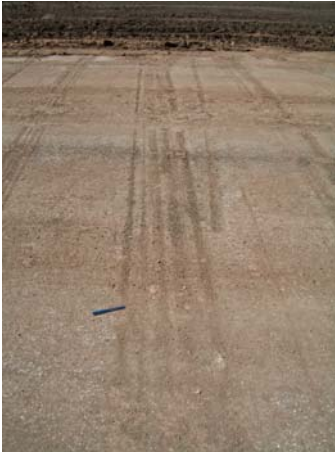
Figure 2. Road surface scoring from rocks carried in slide material mass.

*During the week of 13Jun05, Newmont and NDOT assessed the roadway and pavement condition; minor pavement repair was completed and **SR766 was reopened for traffic on 17June!***
